GERVASIO & ASSOC., INC.

RE: GEORGIA AVE., 10 W.
Peachtree Lane Improvements, Phoenix, Arizona
FOUNDATION DAMAGES INVESTIGATION
G&A Job No. 2171 F

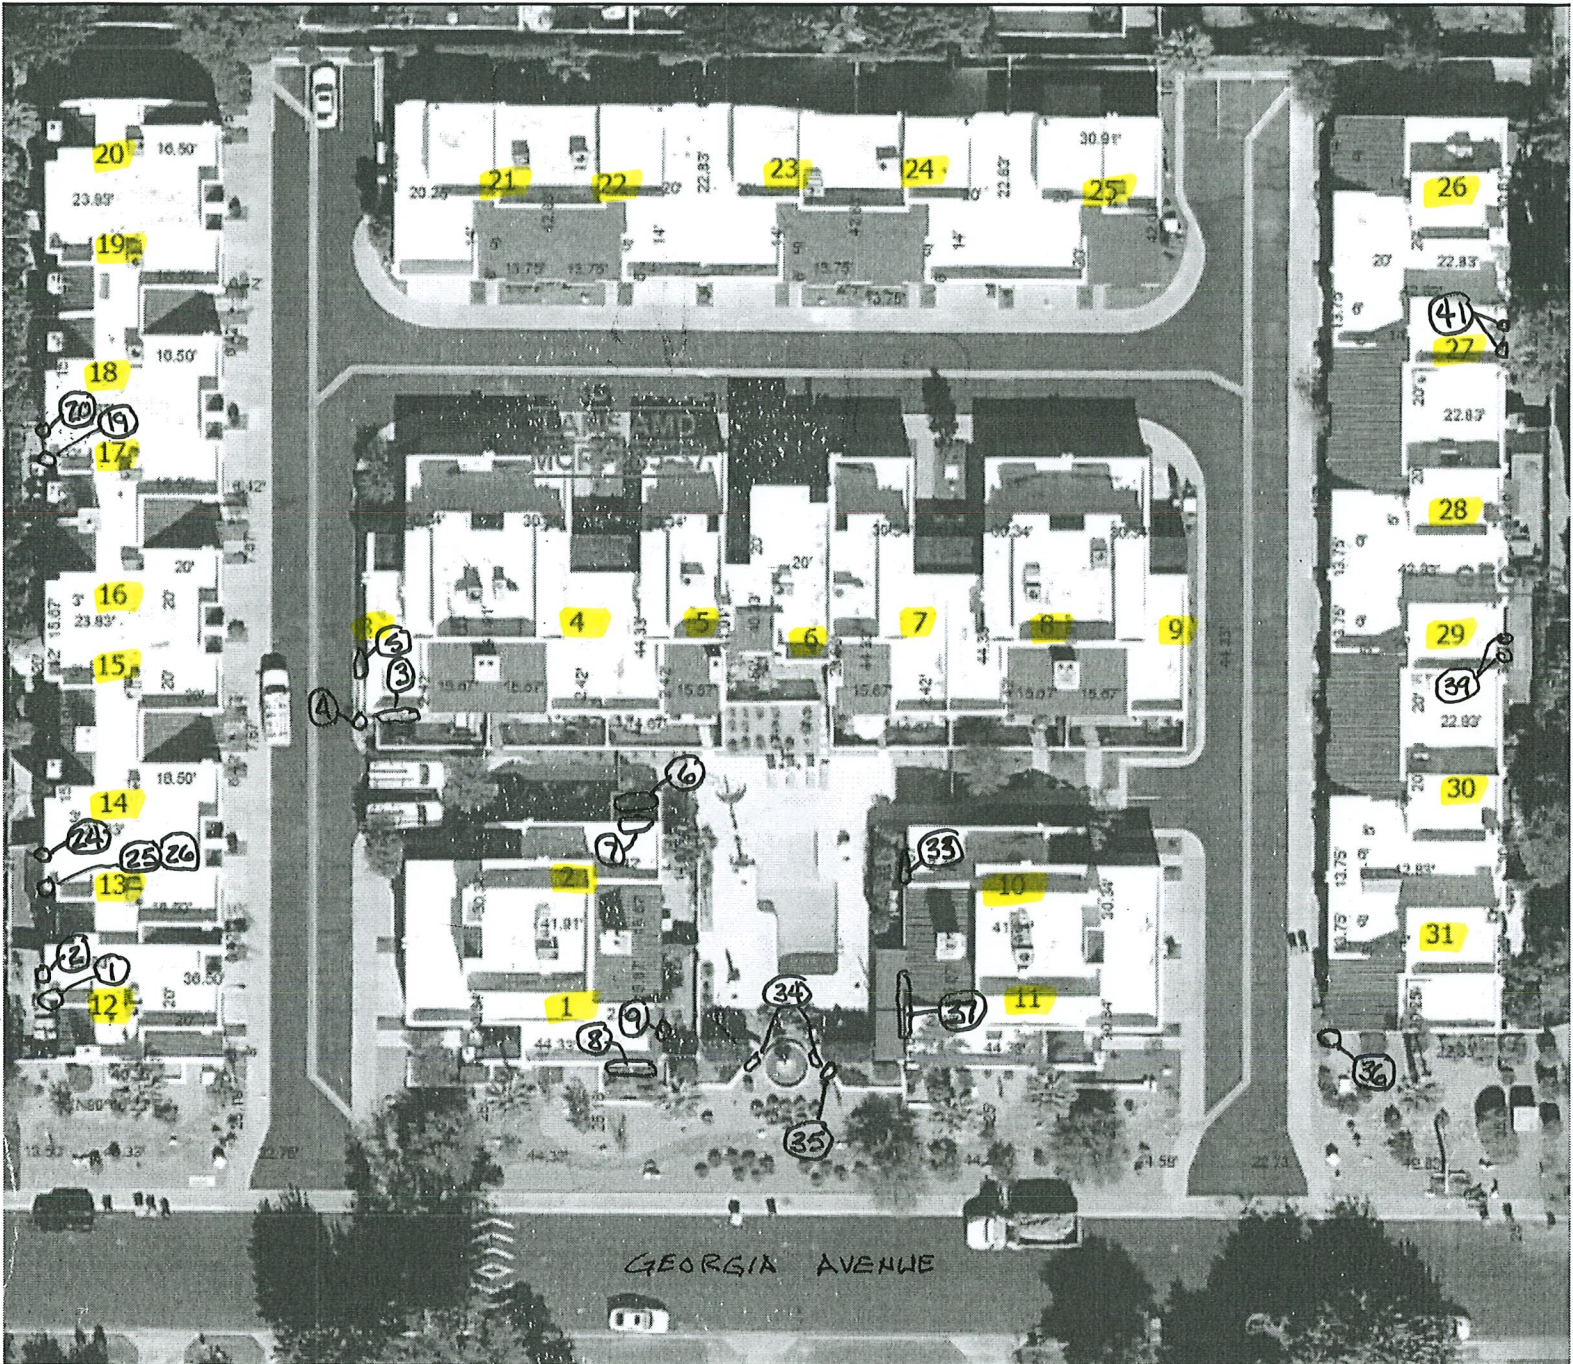
GEORGIA AVE, 10 W
G&A JOB No. 2171
11/15/2022
KEYNOTE PLAN/DAMAGE

We observed concrete foundation stem wall damages at twelve (12) locations, and at one (1) location concrete planter wall damage. There are six (6) locations that have peeling paint on the foundation stem walls but no visible damage to the underlying concrete. We looked for, but did not observe, damages at eight (8) locations, and no one was home at fifteen (15) units so these patios were not accessible.

- At the planter at the southeast corner of Unit 1, along the north wall of the building (Keynote #8 & Photos A47-A56); and
- At the back patio of Unit 17, along the west wall of the building, left of the patio door (Keynote #20 & Photos A75-A77).

- At the back patio of Unit 12, there is a vertical to horizontal crack at the corner of the foundation wall (Keynote #1 & Photos A4-A6). There is also a crack along a patch in the foundation wall on the right side of the patio door (Keynote #2 & Photos A7-A8)

- At the back patio of Unit 3, there is a horizontal crack along the north foundation wall west of the patio door (Keynote #3 & Photos A19-A24). There is another horizontal crack at the east end of the patio, under the bay window (Keynote #3 & Photos A25-A26).

- Within the pool equipment enclosure, there is a horizontal crack along north foundation wall of Unit 2 (Keynote #7 & Photos A40-A44).
- At the back patio of Unit 1, there is a horizontal crack in the east foundation wall under the window (Keynote #9 & Photos A57-A61).

- At the back patio of Unit 13, there is a horizontal and vertical crack at the right side of the patio door (Keynote #25 & Photo A84).
- There is a vertical crack in the concrete planter wall and cap at the planter to the east of the fountain at the south end of the pool area (Keynote #35 & Photo A104).

- At the southwest corner of Unit 31, along the south wall, there are horizontal and vertical in the foundation wall (Keynote #36 & Photos A105-A108).
- At the back of Unit 29, there are vertical cracks and concrete spalling in the east foundation wall at each end of the patio door (Keynote #39 & Photos A121-A122).

- There are cracks in the corner of the foundation wall at the southwest corner of Unit 3 (Keynote #4 & Photos A27-A28); and
- At the back patio of Unit 17, there is surface spalling of the concrete foundation wall under the right end of the patio (Keynote #19 & Photos A73-A74).

- Unit 3 - west foundation wall at planter (Keynote #5 & Photos A29-A31);
- Unit 13 - left of patio door (Keynote #24 & Photos A8-A83);
- Unit 10 - west foundation wall at patio (Keynote #33 & Photos A92-A100);
- Fountain Planters - east and west planters (Keynote #34 & Photos A102-A104);
- Unit 11 - west foundation wall at patio (Keynote #37 & Photos A109-A118); and
- Unit 27 - east foundation wall at patio (Keynote #41 & Photos A125-A126).

At the pool equipment enclosure at the northeast corner of Unit 2, the concrete slab for the equipment is cracked. The slab also has a hollow sound when tapped with a hammer (Keynote #6 & Photos A37-A39 & A45).
